Codornices Creek Restoration Project

2019 Monitoring Report

Phase 3 Geomorphic Monitoring

City of Albany / City of Berkeley

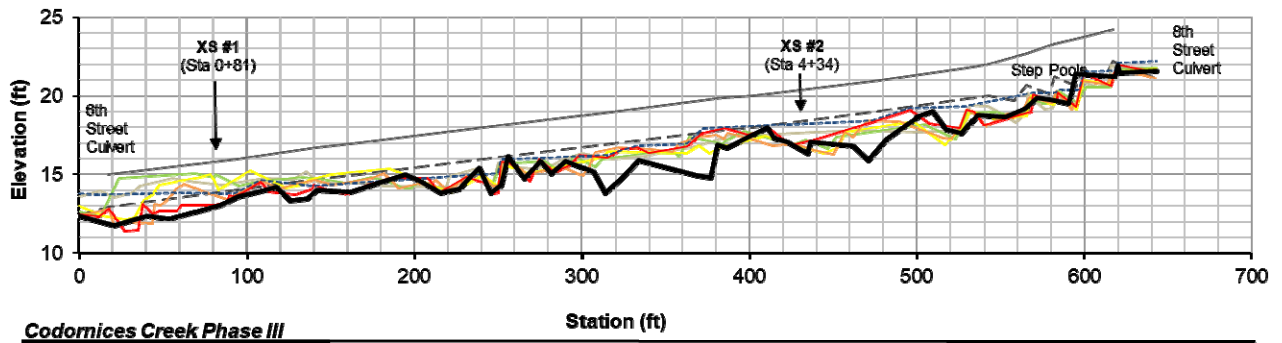
Codornices Creek Phase III
Channel Profile

Riffle and pool morphology continue to develop within the channel with the exception of areas scoured to hardpan. The hardpan is hampering sediment deposition in these areas and limiting development of depositional feature such as point bars. There are some areas of concern where channel degradation has occurred near where the hardpan has been exposed.

Monitoring of this condition began during the first winter after construction and has not shown any indication of improvement. The channel has incised 1-foot below the design grade in many

areas, with a few locations up to 3-feet, resulting in increased stream power near bankfull flows. In addition, the floodplain is no longer inundated at the designed frequency.

We have recommended two approaches to address this condition in prior reports. The first is to construct rocked riffles that raise the grade. While this can work and has some benefits, it is not the preferred approach. Instead we recommend using wood, either as a passive or active approach to provide additional roughness to help capture sediment.

- 1.4.1. Allow vegetation to remain in the channel to encourage minor debris jams and backwatered pool habitat. Use small limbs pruned off willows and place downstream of pools perpendicular to channel.
- 1.4.2. Consider actively installing woody debris jams similar to Beaver Dam Analogs to accelerate deposition within this reach.

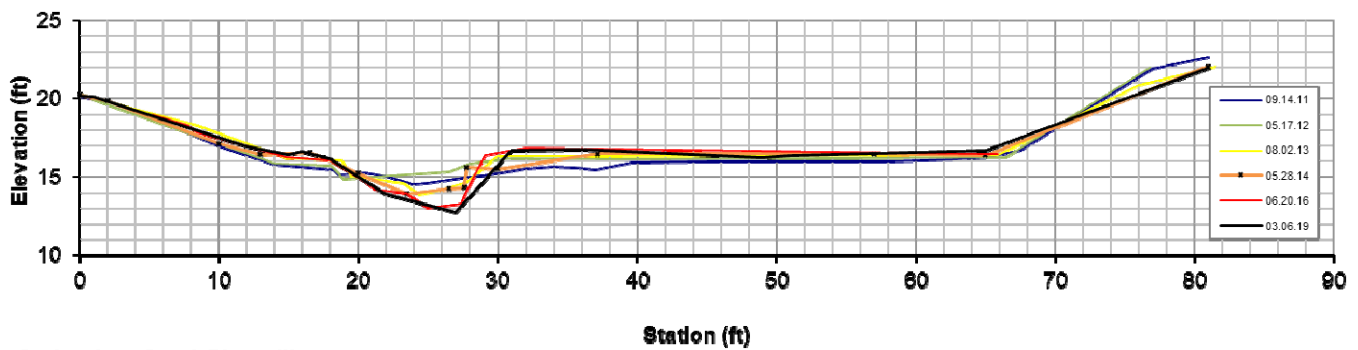
Codornices Creek Phase III
Cross Section 1
Profile Station 0+8.1

The two riffle cross sections were resurveyed in 2019. Cross section #1 is in the lower portion of the creek and is influenced by the culvert backwater. Cross section #2 is upstream in the location adjacent to the hardpan bed. Cross section 1 has remained stable after narrowing the first four year after construction. Cross section 2 has also remained stable after building an inner depositional bench the first four years after construction. The thalweg has maintained a consistent elevation for the duration of the monitoring period.

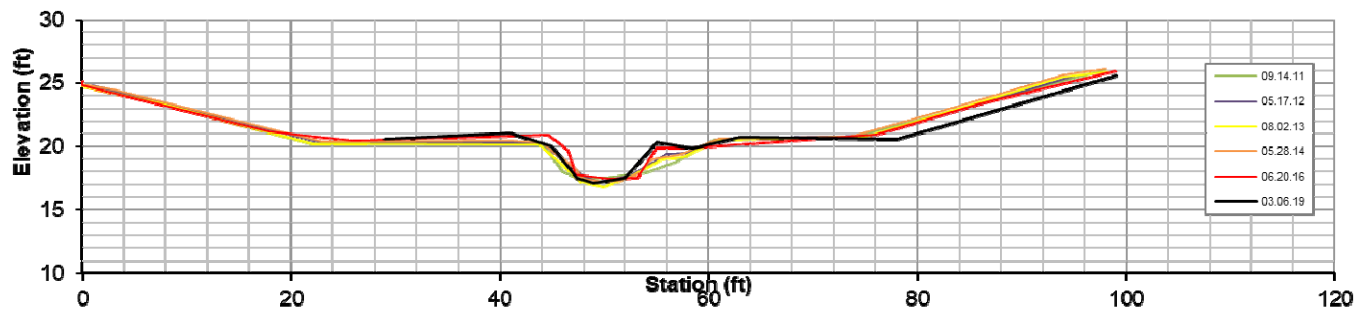
Codornices Creek Phase III
 Cross Section 2
 Profile Station 4+34

Expose Hardpan –The exposed hardpan upstream continues to persist. This hardpan substrate excludes any opportunity for hyporheic flow and does not provide ideal habitat for benthos. This condition is not unique to the restoration areas. A similar condition exists upstream of the project site between 8th and 9th street.

In the lower part of the hardpan, the creek seems to have eroded through the hardpan down to a softer substrate. We will continue to monitor this development.
