Codornices Creek Restoration Project

2015 Monitoring Report

Phase 3 Vegetation Monitoring Phase 1-3 Stream Temperature Monitoring

City of Albany / City of Berkeley

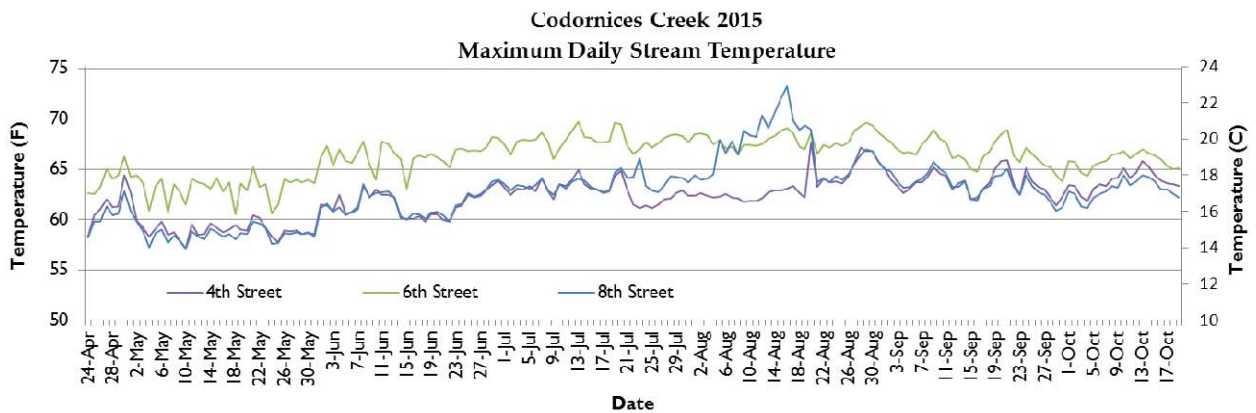
Looking at the chart above, between July 15 and August 26 the 8th street data logger appears to have recorded ambient air temperature and not water temperature. This is understandable due to the exceedingly low water levels experienced in the creek during the prolonged drought. To best analyze the data, results exclude data within this date range.

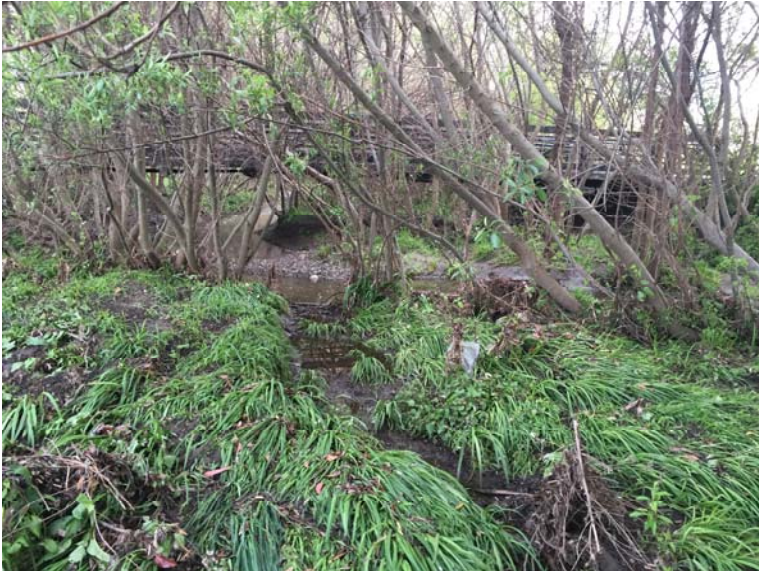
Phase 1 is now 12 years old and has recently begun to experience vegetation dynamics more typical of a mature willow riparian environment, most notably with large willows leaning into the channel and obstructing flows in the low flow channel. In multiple locations these willows have collected debris entrained during storms. These small debris jams have begun to create backwaters and low wood step structures. These have in turn, provided additional support for the development of channel evulsions. There are now at least one location with a secondary channel (anabranh) that is activated during flows less than bankfull flow conditions. This evolution is adding complexity to the creek system through this site and is a welcome development. No infrastructure is anticipated to be impacted by these debris jams and anastomosis.

Figure 1: Secondary channel developing on floodplain

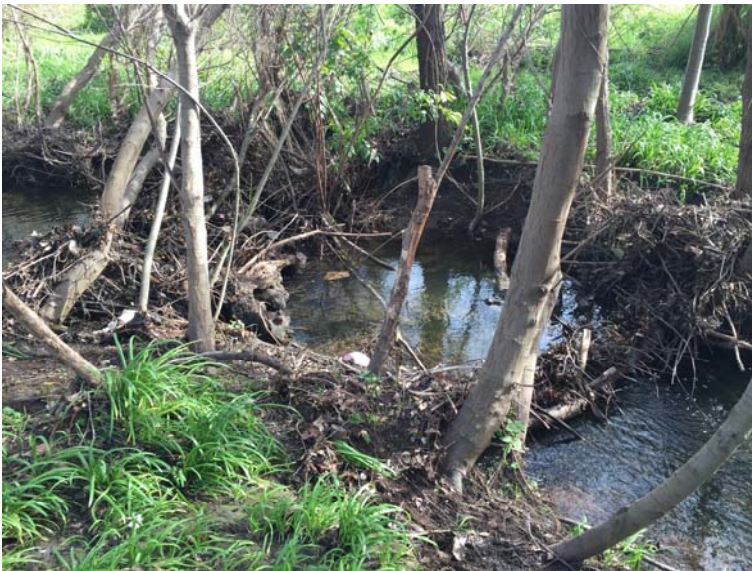
Figure 2: Debris jams developing against leaning mature willow trunks.
