Benthic Macroinvertebrate Report

Codornices Creek 2018 - 2019

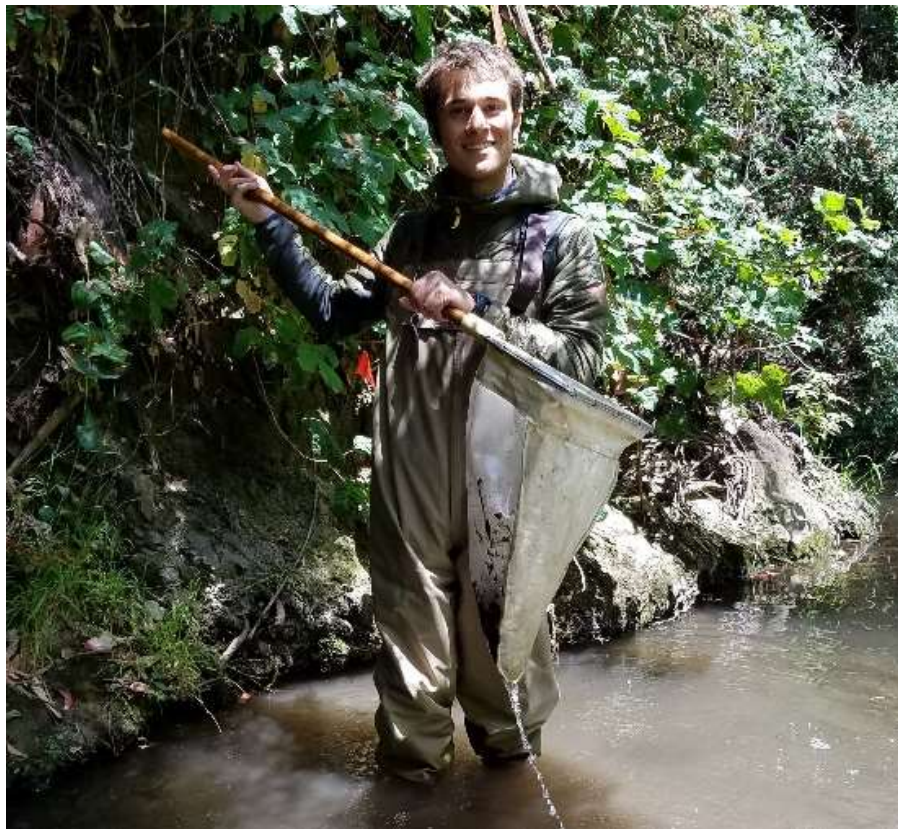
Grier Gammon holds the D-net used to collect BMI.

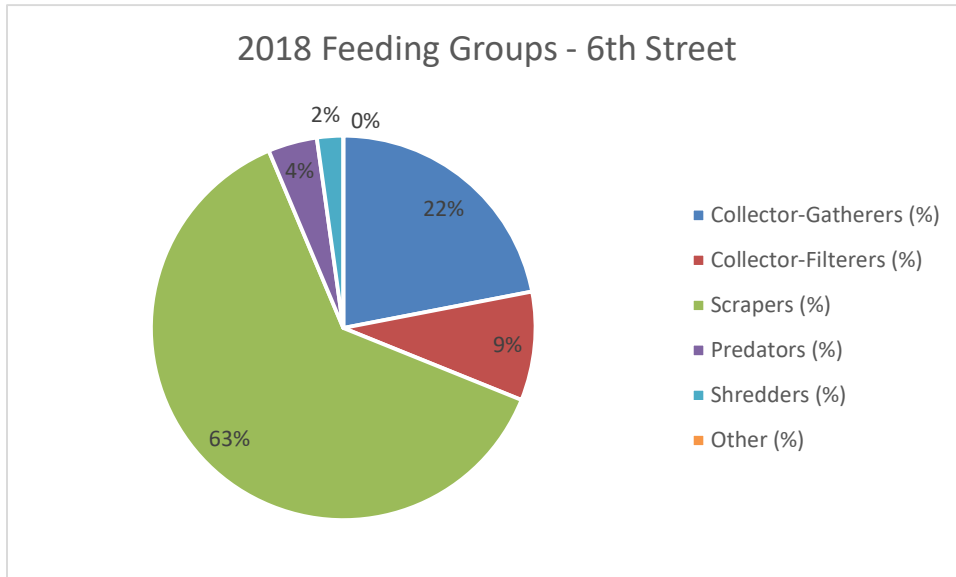
Figure 5: Feeding groups at 6th St in 2018.

At 6th St, the composition of collector feeding types changed a little between 2018 and 2019: collector-filterers decreased, while collector-gatherers increased. The dominant feeding group for both years was scrapers.

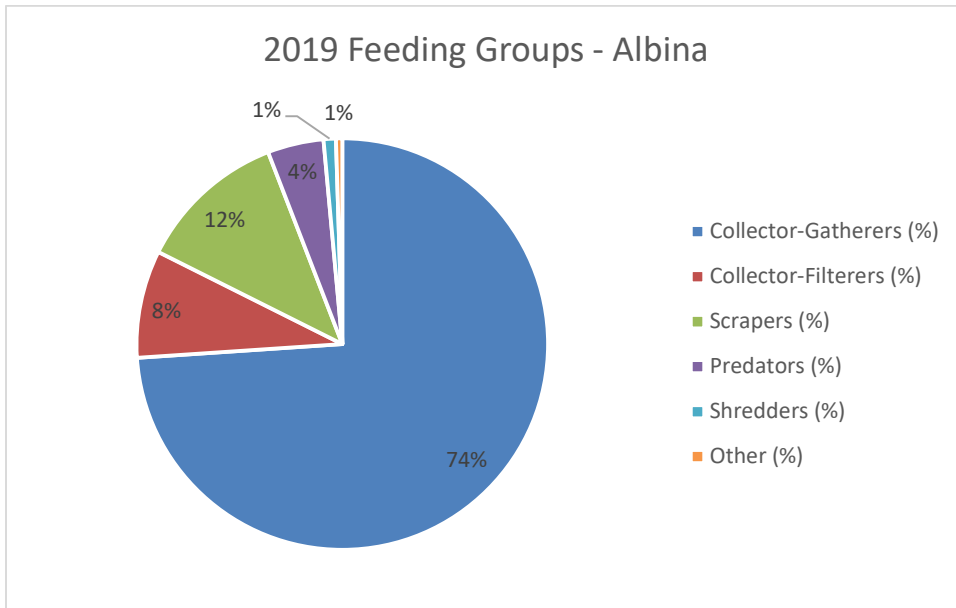
Figure 10: Feeding groups at Albina Ave in 2019.

At Albina Ave, the dominant feeding group for both years was again collectors, and a similar increase in collector-gatherers and a decrease in collector-filterers was also seen at this site from 2018 to 2019.
