Technical Memorandum

Prepared for: **City of Albany, California**
Prepared by **Hagar Environmental Science**

Codornices Creek – Restoration Activities between 2nd Street and 5th Street Fish Removal Activities

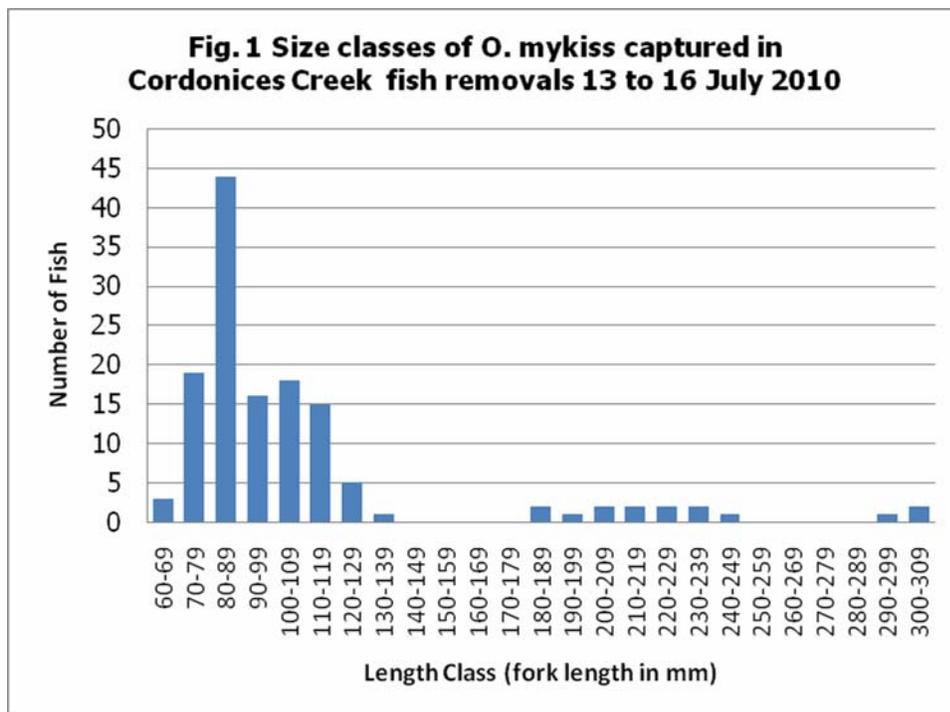
The size range of *O. mykiss* captured was similar to those captured during removals downstream during Phase II in 2006, but the distribution among size classes was somewhat different. Additionally, the overall numbers caught, in this year's larger project area, are greater with 136 trout captured. In 2004, the majority of trout were in the 150mm to 250mm size range (HES 2005) while in 2006, the majority were less than 160mm. In 2010, the majority of fish are in the 70 to 100mm size classes (Figure 1). The smaller trout, 90mm fork length and less, could be extremely fast growing young-of-year, possibly from spawning early in the season (January or February), or "1+" year-old fish from the previous season. Most of these fish appeared to have high condition factors (high weight to length proportions) and to be well fed. The section of Codornices Creek between 6th and 8th Streets has significant areas lacking tree cover and thus allowing lots of sunlight to reach the stream, making it very productive. This portion of Codornices Creek is relatively cool due to its proximity to San Francisco Bay and lack of full tree cover does not necessarily imply intolerably high stream temperature. Sunlight stimulates growth of aquatic plants and invertebrates and *O. mykiss* grow best at temperatures near their upper tolerance levels as long as abundant food is available. The population size structure in 2010 is consistent with Central California steelhead populations where the transformation from parr to smolt typically occurs after two seasons of rearing at a size of about 150mm (6 inches) and few fish larger than 150mm are found. The larger trout would have remained in the stream past the typical stage of parr to smolt transformation and are likely following a resident or non-migratory life-history strategy.
